**THE STREAMBANK EROSION CONTROL  
EVALUATION AND DEMONSTRATION ACT OF 1974  
SECTION 32, PUBLIC LAW 93-251**

**Appendix E - Missouri River Demonstration Projects**

# FINAL REPORT TO CONGRESS

A COMPREHENSIVE SUMMARY REPORT ON TWENTY-EIGHT  
STREAMBANK EROSION CONTROL DEMONSTRATION PROJECTS ON  
THE MISSOURI RIVER IN THE THREE REACHES: GARRISON DAM  
TO LAKE OAHE, FT. RANDALL DAM TO NIOBRARA, AND GAVINS  
POINT DAM TO PONCA

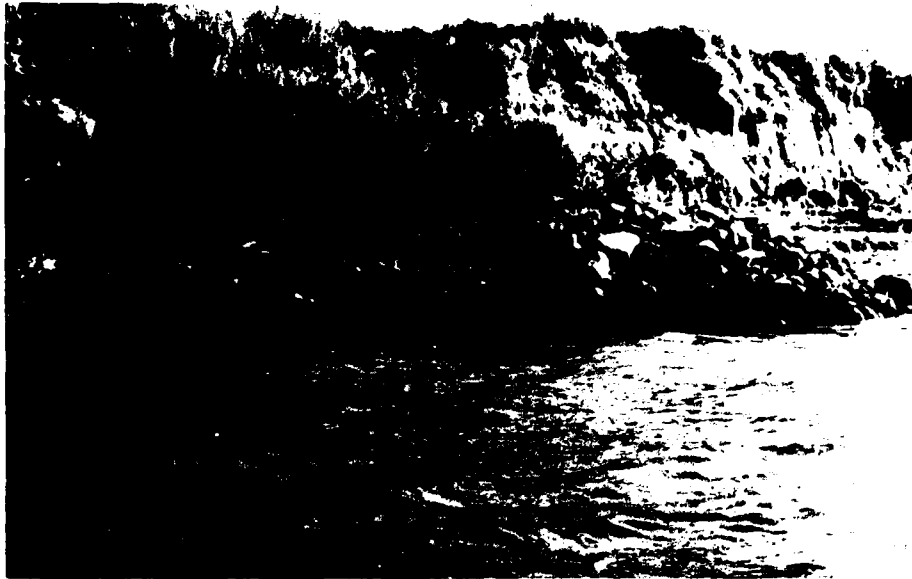
Photo 4. Hardpoint 1366.8, approximately 9 months after completion.  
(Photo taken July 1979)

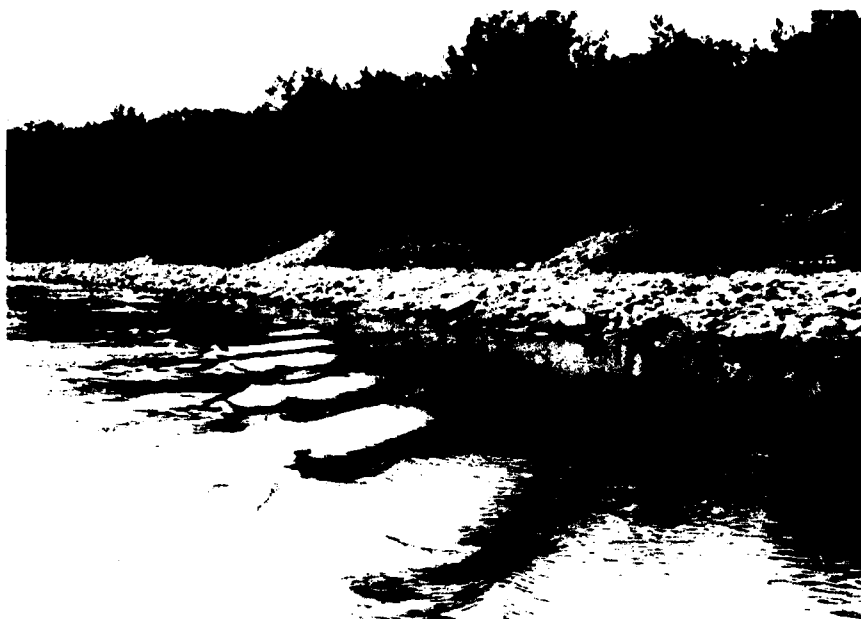
Photo 8. Reinforced Revetment 1357.73, approximately 8 months after completion. (Photo taken 22 August 1979)

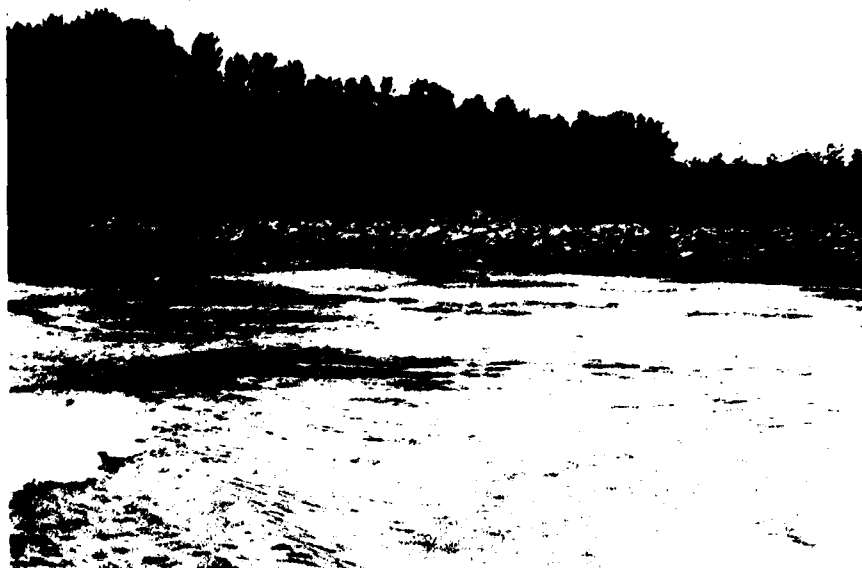
Photo 9. Downstream portion of Reinforced Revetment 1357.73 approximately 8 months after completion. (Photo taken 22 August 1979)

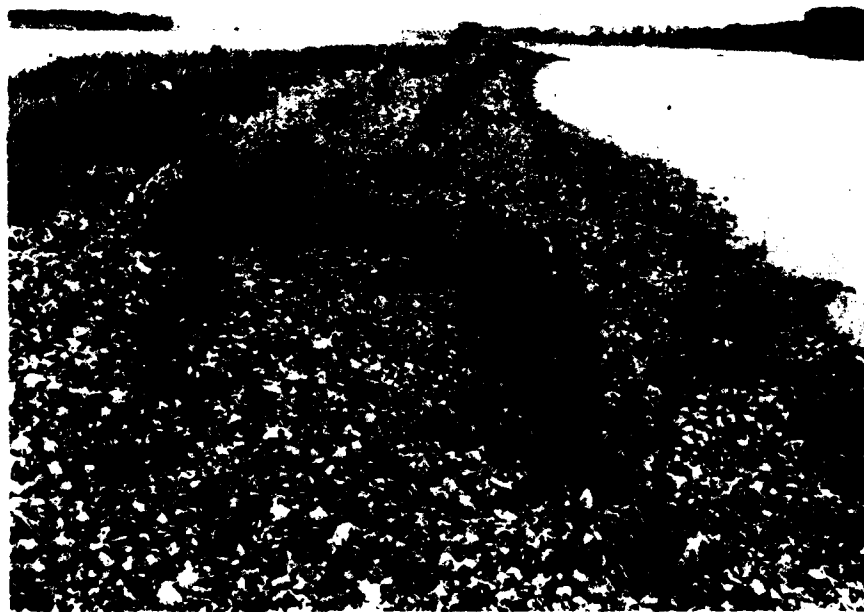
Photo 18. Looking upstream along upstream side of Earth Core Dike 1345.5, 2 months after vegetation planting in May 1980. (Photo taken 17 July 1980)

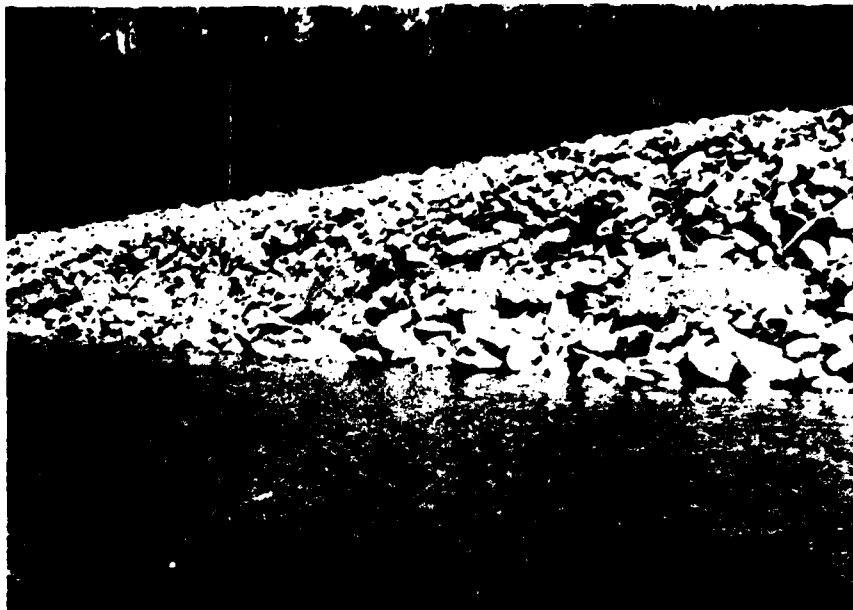
Photo 25. Windrow Revetment 1323.8, Station 0+00 to 4+40, approximately 15 months after completion. (Photo taken June 1978)

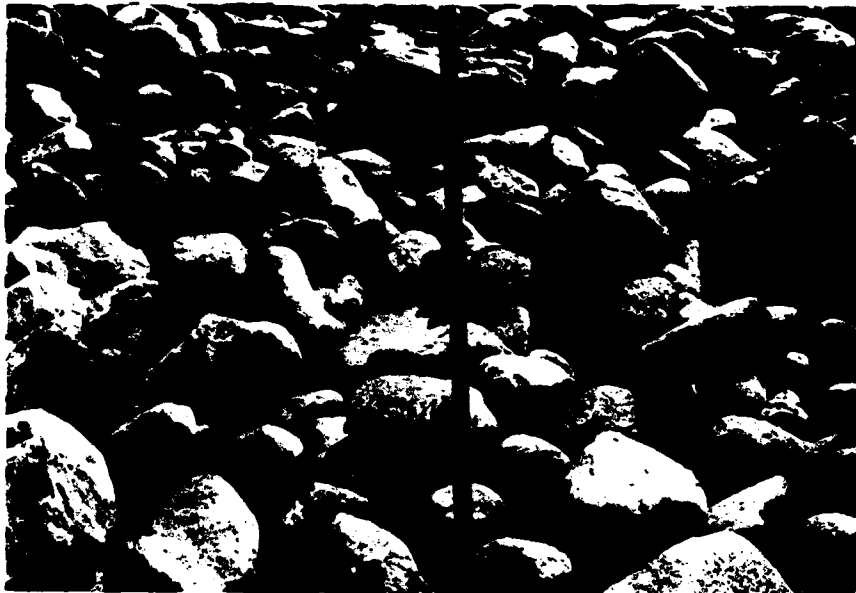
I-94 Area  
Photos 37 and 38

Photos 38 and 39 show 500 lb. and 200 lb. gradation tests. The stone material used in the construction of this project was required to meet the following standards: bulk specific gravity, saturated surface-dry basis, Method CRD-C 107-69, required not less than 2.35. Soundness in magnesium sulfate, ASTM Standard C88-76, required a loss of 5 cycles of not more than 12 percent; soundness in freezing and thawing for Ledge Rock Method Modified Designation T103-62, required a loss at 12 cycles not to exceed 10 percent.

Photo 38. 500 pound gradation test. (Photo taken 12 May 1980)

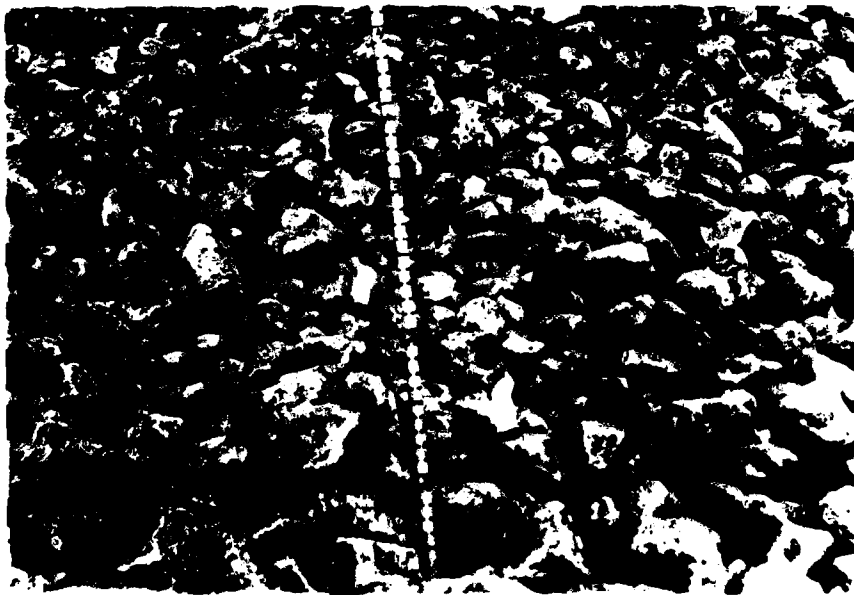
Photo 39. 200 pound gradation test. (Photo taken 12 May 1980)

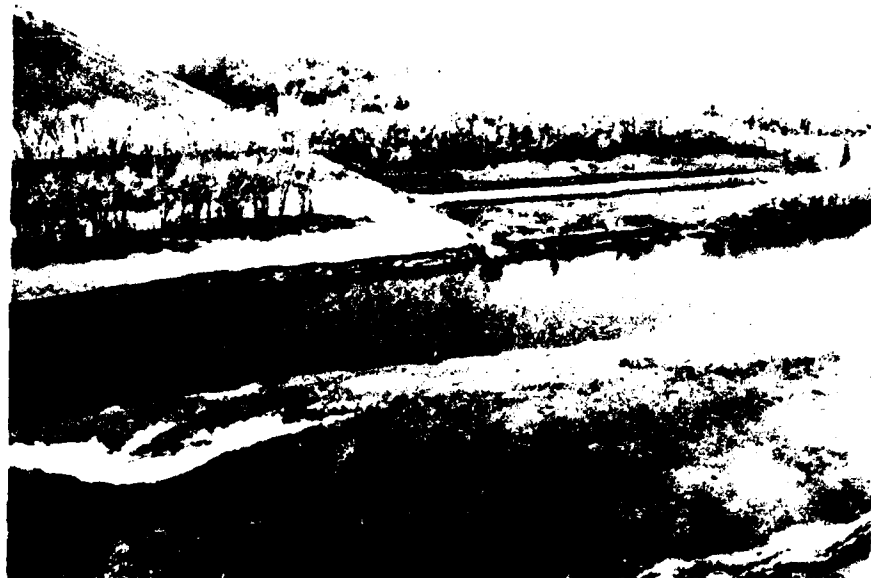
Photos 44 and 45 show typical eroding banklines along the Price-  
Part I (Phase I) project area.

Photo 44. Aerial view of Price-Part I Phase I area,  
prior to construction. (Photo taken  
15 April 1980)

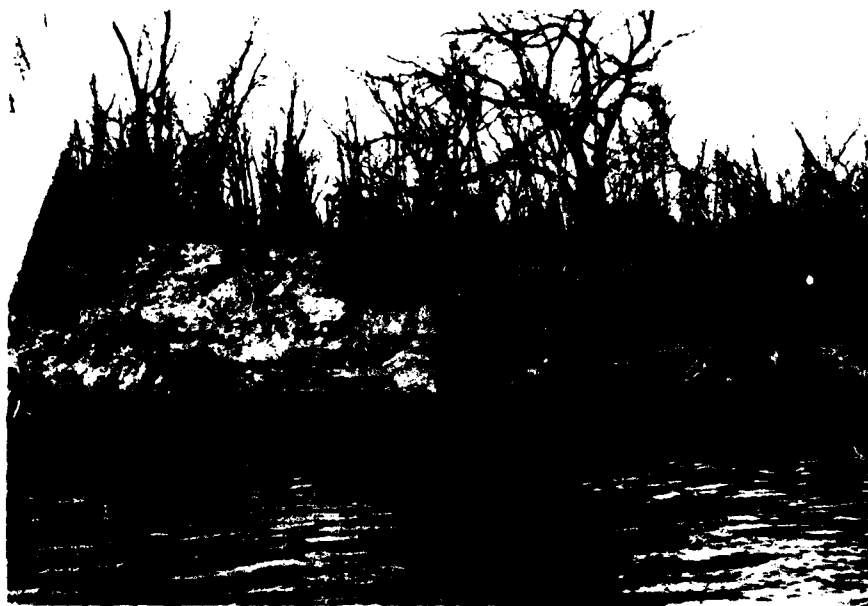
Photos 50 and 51 show typical eroding bankline along the Horseshoe Butte (Phase I) project area.

Photo 50. Typical eroded bankline along upstream portion of the Horseshoe Butte-Phase project area. (Photo taken 9 October 1980)

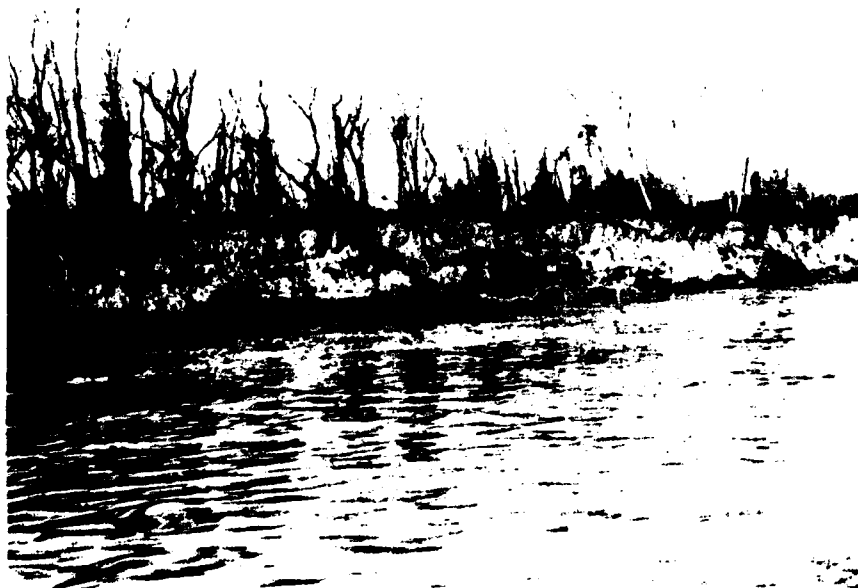
Horseshoe Butte-Phase I Area  
Photos 50 and 51

Photo 51. Typical eroding bankline along Horseshoe Butte-Phase I project area. (Photo taken 9 October 1980)

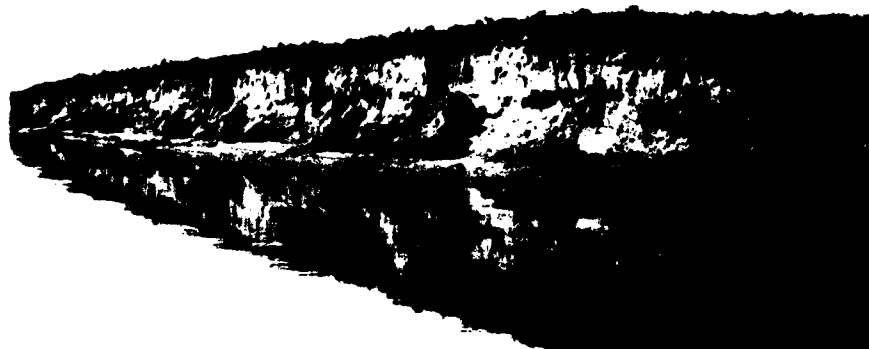
Knife Point-Part II-Phase I Area  
Photos 52 and 53

Photos 52 and 53 show typical eroding bankline along the Knife Point - Part II (Phase I) project area.

Photo 53. Typical eroding bankline along downstream portion of the project area. (Photo taken 18 July 1980)

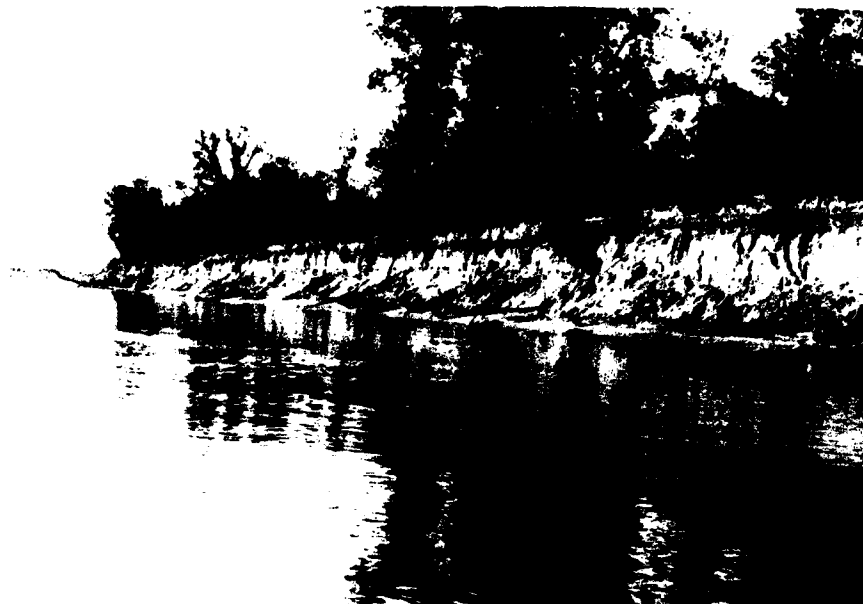
Hancock-Phase I Area  
Photo 54

A photograph of a typical eroding bankline along the Hancock  
(Phase I) project area is shown on Photo 54.

Photo 54. Typical severely eroding bankline along Hancock-Phase I project. (Photo taken 18 July 1980)

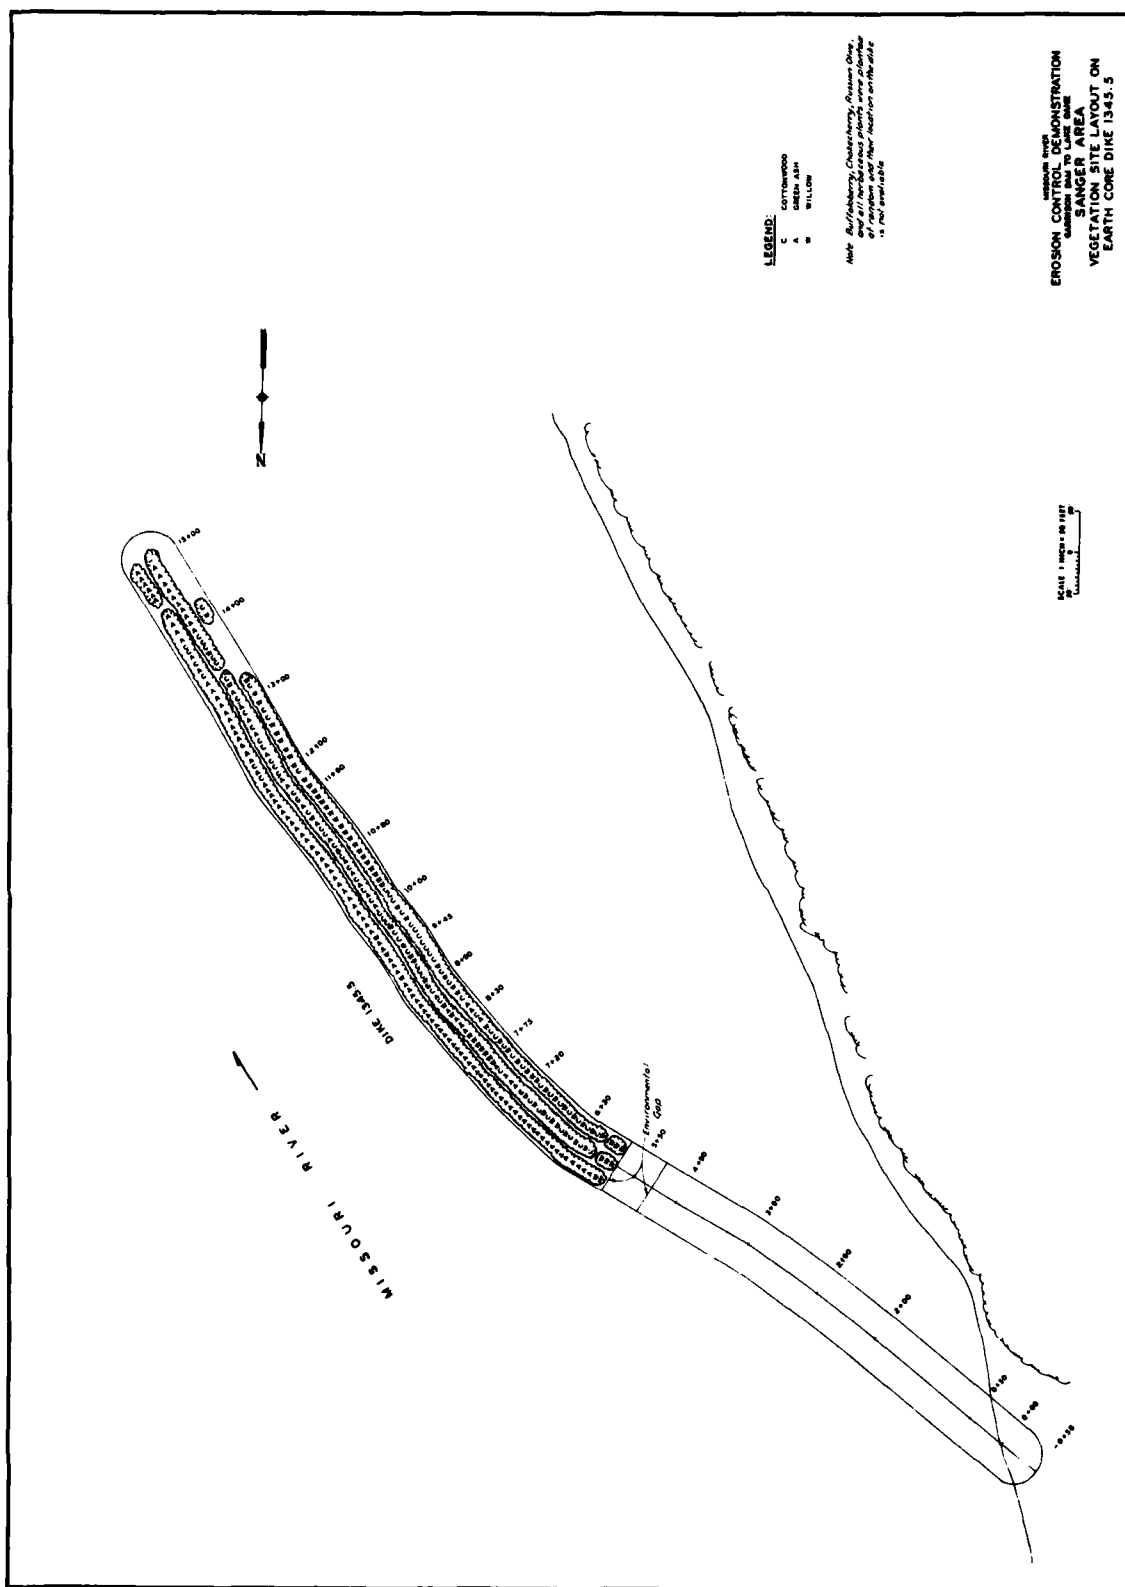
PLATE 7-7

(1) The revegetation planting at this site was undertaken on a portion of the 1,500 foot earth core dike structure 1345.5, as shown on Plate 7-7. There were 2,600 woody plantings placed on the earth core dike, riverward of the environmental gap, and on the downstream side of the dike. The original plan called for approximately 4,700 individual woody plants but was reduced because of lack of suitable planting area left by the contractor who constructed the dike. Conditions also precluded any planting of herbaceous material.

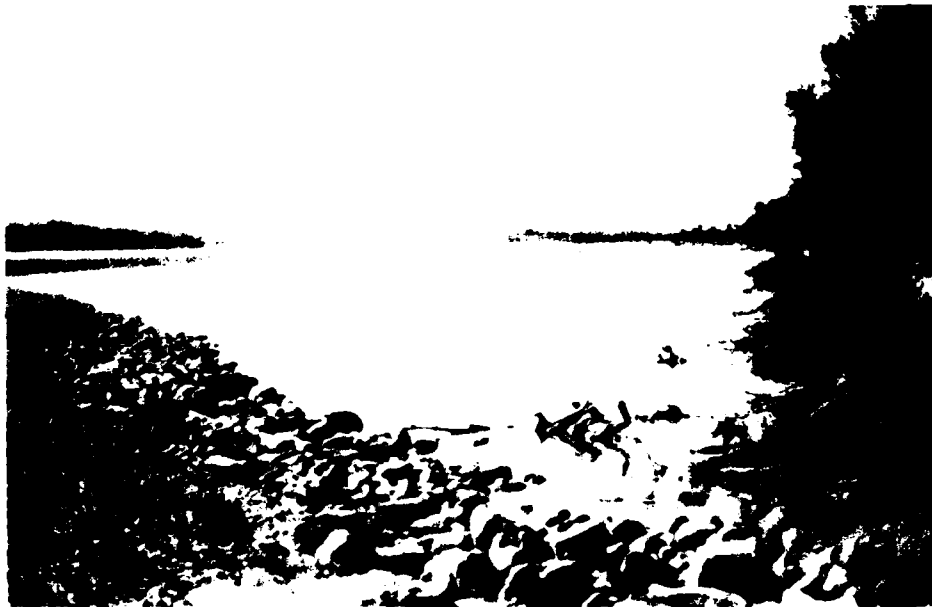
No. 4. - Sanger

At the Sanger site, a large backwater area was created behind the earth-core dike (Photo No. 4). In these backwater areas the water warms up faster and submerged aquatics have a chance to become established. This type of habitat provides a nursery area for many fishes including walleye, northern pike, crappie, white bass, white sucker and carp. Previous sampling efforts in areas similar to this one has confirmed this conclusion.

One problem with the earth-core dikes is that the area behind them has a tendency to become silted in or the lower end closes off completely. If this is combined with a decrease in the water releases from the dam, many small pools remain and the fish become stranded. The environmental notches and culverts through the dike were supposed to keep the areas behind the dikes from becoming silted in. While this is good in theory, it does not appear to have worked well in practice. At one site, instead of a large backwater area below a culvert, a narrow, shallow channel had been formed. As river levels receded, an isolated chute developed, deepest by the dike and dry at the lower end. This type of situation does little to benefit the fishery and can actually be a detriment to it. Young-of-the-year fish that might have stayed in the main river are now trapped in these isolated pools.

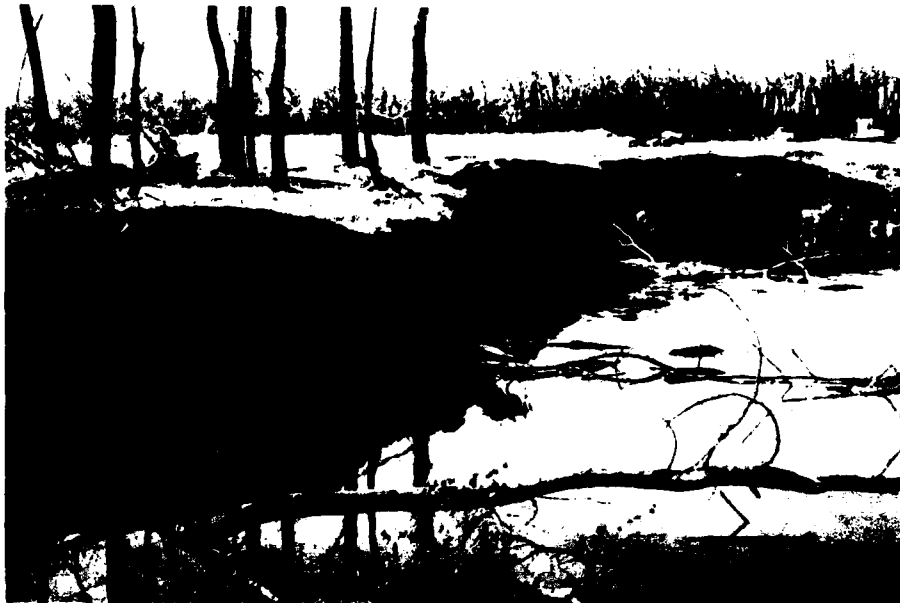
No. 5 - Eagle Park

Project construction has resulted in minimal habitat destruction. To date, we have documented approximately 3 acres of habitat lost. This all occurred at the Sanger site where a brushy hillside was cleared and the area was used as a borrow site (other previously cleared areas were already available). At other sites, individual trees have also been lost either due to direct removal for a project feature or because of structure placement (Photo 5). Generally, the amount of land involved is too small to quantify or would have been lost to erosion.

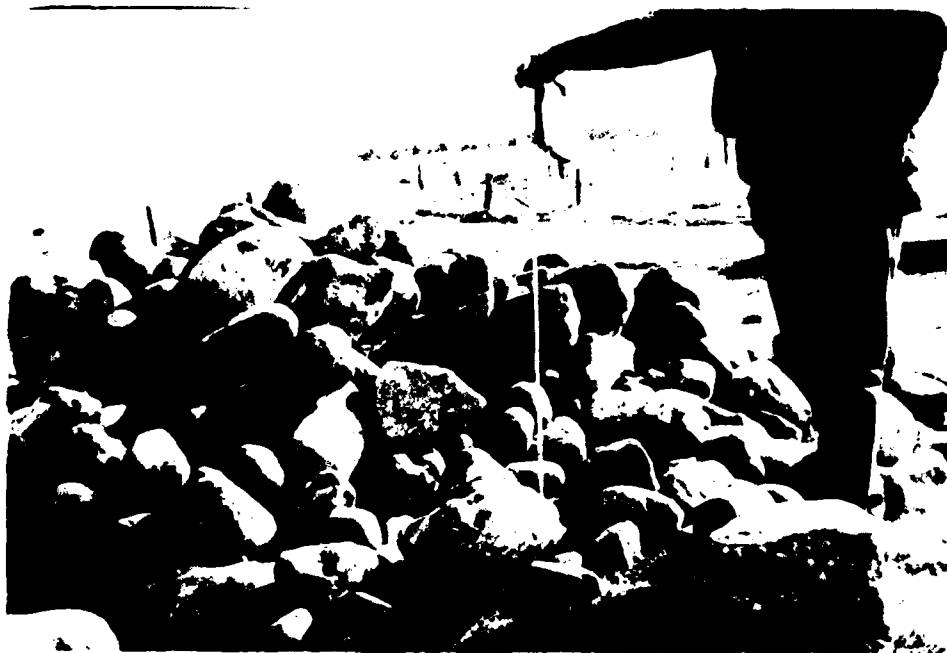
**PHOTO 2. 500 LB. GRADATION STONE**  
(Photo Taken September 1980)

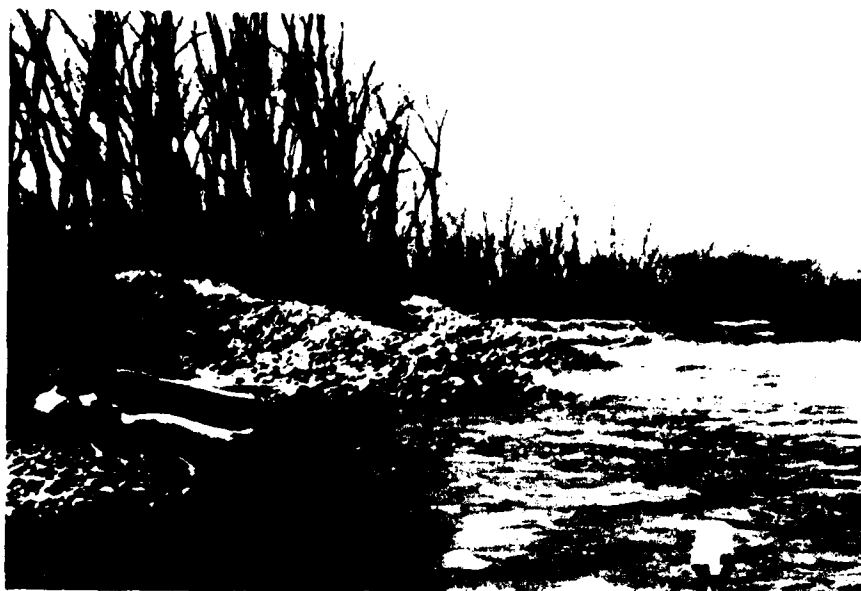
**PHOTO 11. HARDPOINTS 866.9 AND 866.8, APPROXIMATELY  
1 YEAR AFTER COMPLETION. (Photo Taken  
15 April 1980)**

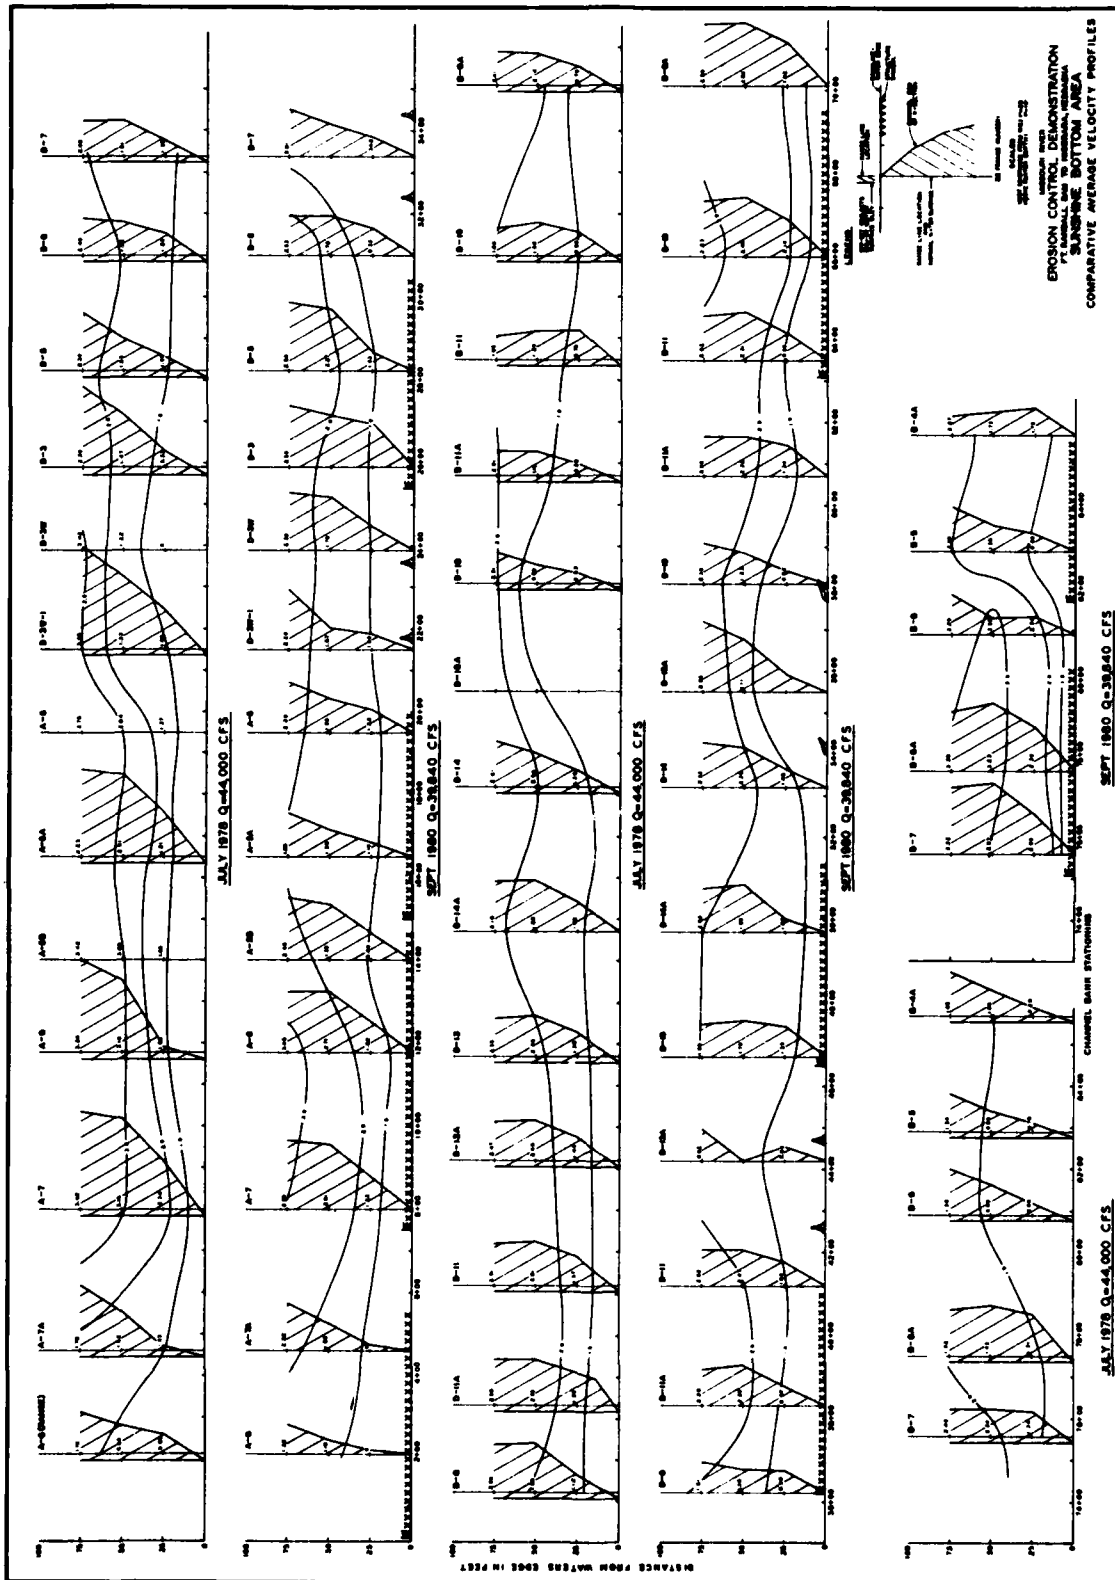
PLATE 2-8

a. The Sunshine Bottom Project has been monitored for 18 months since its completion in August 1979. A bankline location survey and overbank/streambank cross section measurements were taken in July 1978. Velocity measurements were taken in 1978 and 1980. Comparative velocity trends are shown on Plate 2-8. Cross sections were also taken by the contractor upon completion of each structure. The preconstruction bankline location for 1978 and the bankline location for 1980 are shown on Plate 2-1. Controlled aerial photography was taken in 1978 and 1980. Ground level photographs were taken and qualitative structural changes were noted during each field reconnaissance in the project vicinity.
